*MICHAEL NEAL CONSULTING LLC*

William Jerome Ruth

v.

Beartooth Electric Cooperative, Inc., and Asplundh Tree Expert, LLC

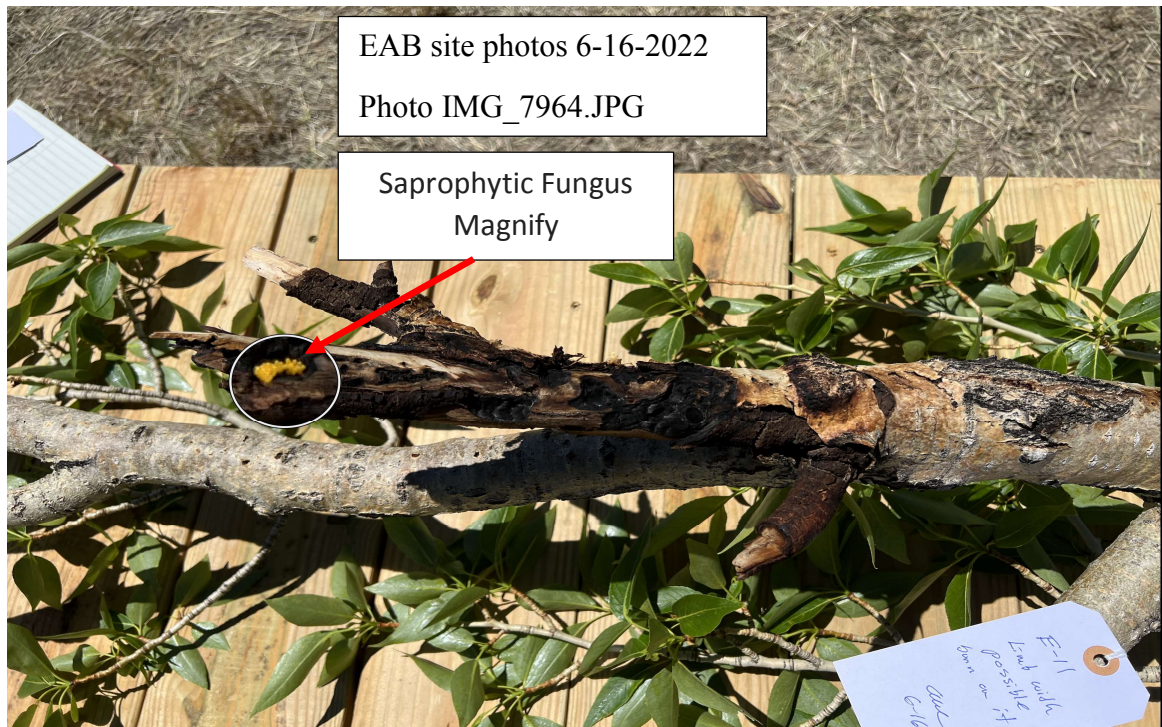
1. E-11 Branch Sprophytic fungus only dead and dying wood.

Images I-K are sooty  
canker which is the same  
in Photo IMG\_7964.JPG

1. The E-11 branch has been dead for at least two to three years and the attached branch had fractured. There is evidence of sooty canker, saprophytic fungus, and wood borer insect on this branch.
2. There was no evidence of any branch attachment or burnt remnants between E-1 and E-11 at or near the west side of the subject tree.
3. There were no ignition sites located within 143 feet of the tree.
4. The E-1 branch was located 55.9 feet east of the subject tree. If the E-1 branch was located on the west side of the subject tree, it would have to travel through the tree without hitting any other

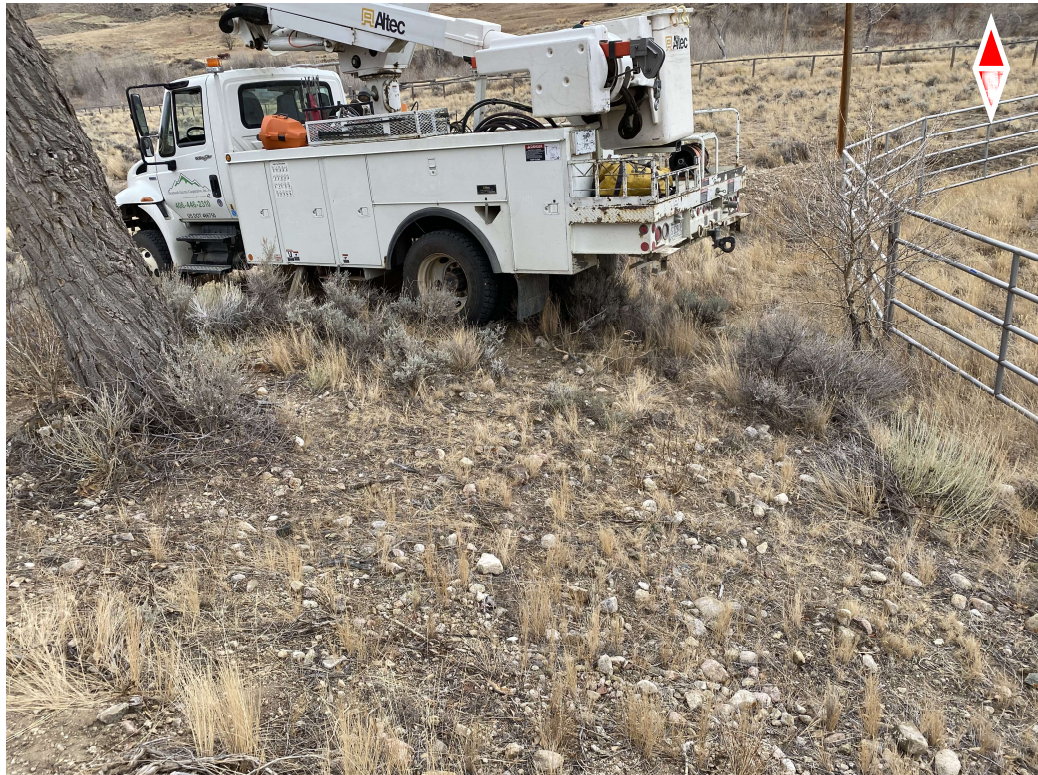
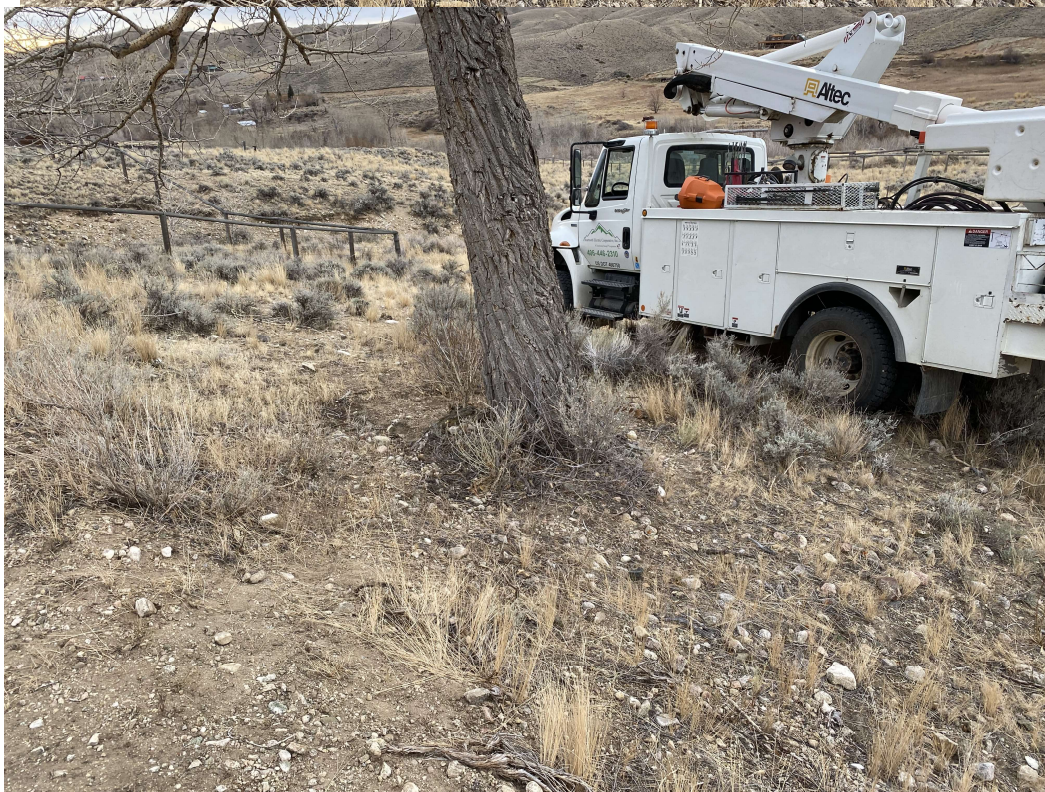
2.

EAB Photo 12-1-2021  
IMG\_5001.JPG  
No evidence of  
burnt branches  
or vegetation.

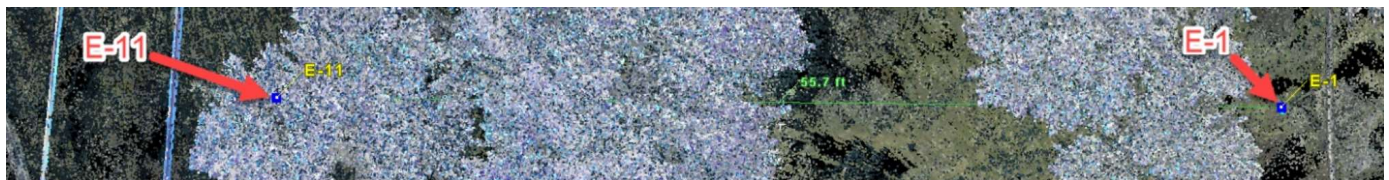
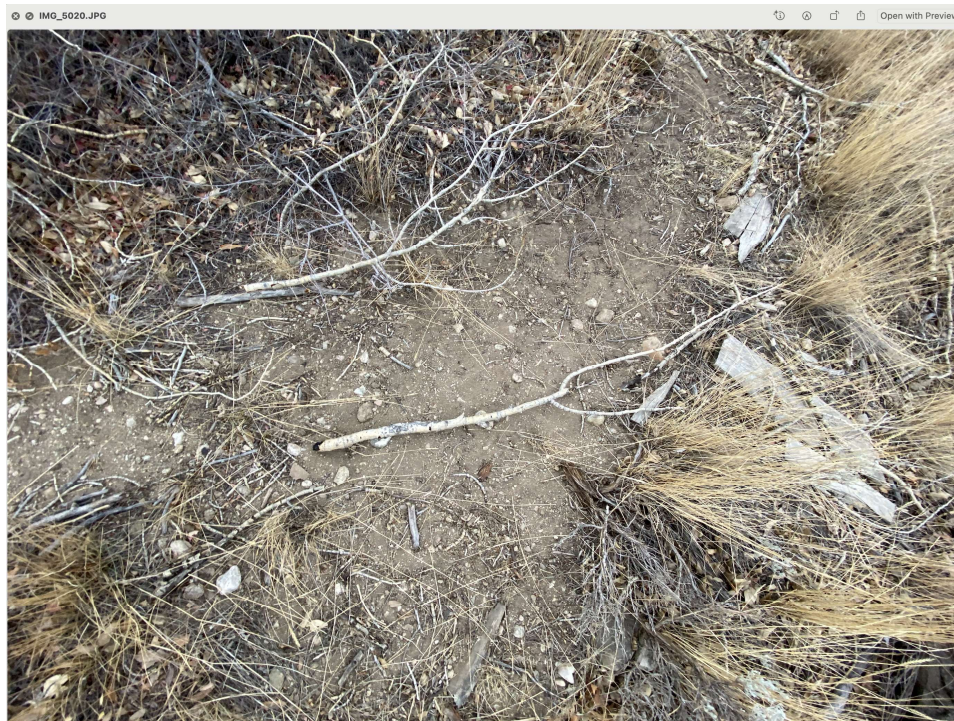
4. The E-1 branch was found 55.7 feet from the E-11 branch.<sup>5</sup>

Approximate location of E-1 branch. No evidence of combustion of ground vegetation.

branches or the trunk of the tree. There was no evidence of any fire ignitions at the E-1 landing site.

As a matter of fact, there was no vegetation where the branch landed.
